Docket No. 217 – Development and Management Plan Inspection

Northeast Utilities Service Company Certificate of Environmental Compatibility and Public Need for the construction of a 345-kV electric transmission line and reconstruction of an existing 115-kV electric transmission line between Connecticut Light and Power Company's Plumtree Substation in Bethel, through the towns of Redding, Weston, and Wilton, and to the Norwalk Substation in Norwalk, Connecticut.

Date: August 30, 2006

Location: Overhead Line (Composite 345kV and 115kV Gallows Hill to Archers Lane,
345kV H-Frame Hoyts Hill to Gallows Hill, and Norwalk Section)

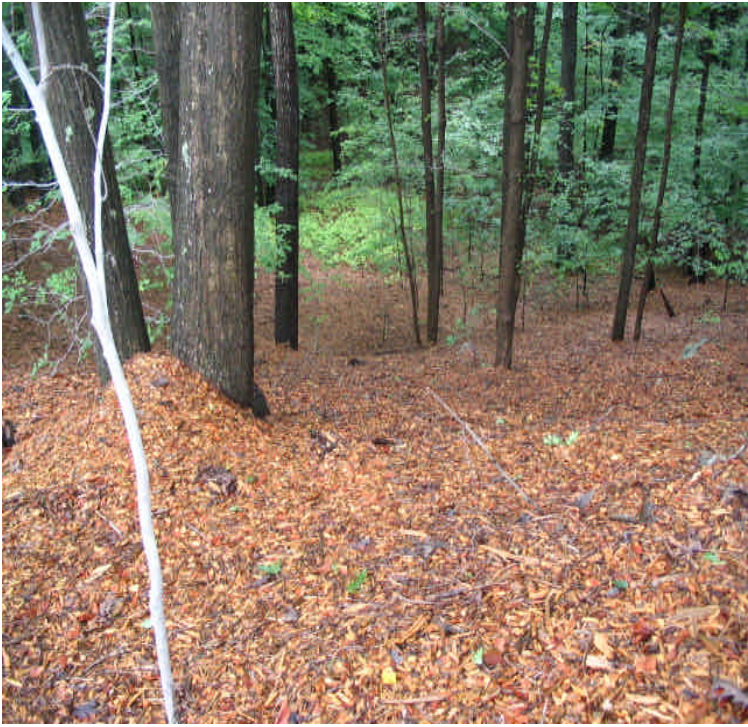
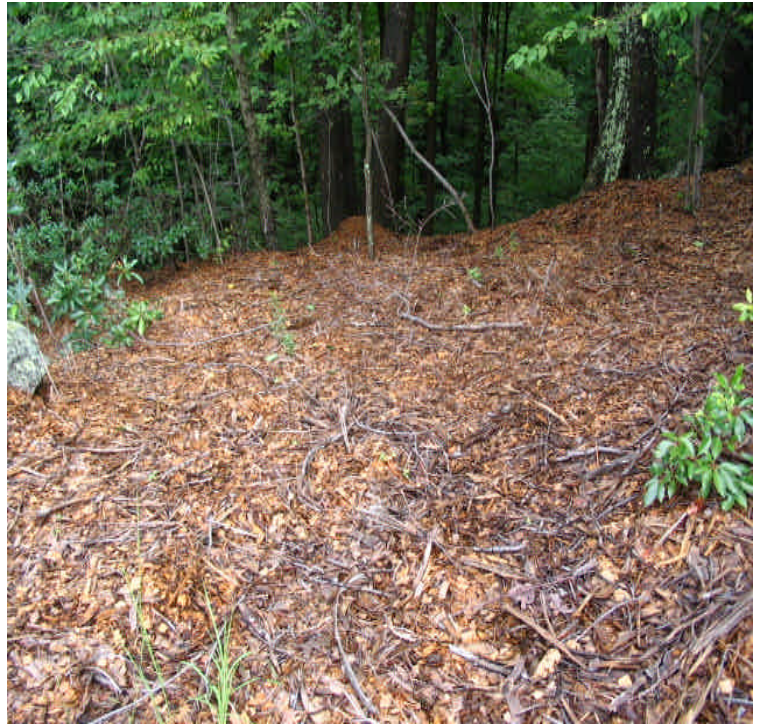
<p>- Although controls upgradient of the 2nd wetland crossing along the Archers Lane access road were repaired, additional run-off caused stone to pile over the fence again. 8/17-8/30/06.</p> <p>- Wood chips had been blown into the uplands and wetland area at the third structure in from Gallows Hill Road. 2/22-8/30/06. Another area with deep wood chips off</p>	<p>- Controls should be maintained as necessary and the stone has to be pulled back from the wetland. More permanent measures will be needed. 8/17-8/30/06.</p> <p>-Make sure chips stay on the ROW. Contractors should remove the off ROW chips since this is not allowed in the D&M plan. 2/22-8/30/06.</p> <p>- Wood chips on the ROW can remain at a</p>	<p>-N/A</p> <p>-Still needs attention (CL&P is looking into a solution here)</p>

(Composite Section): Both photos show the piles of wood chips that were blown into the upland areas beyond the ROW past Archers Lane. 8/30/06

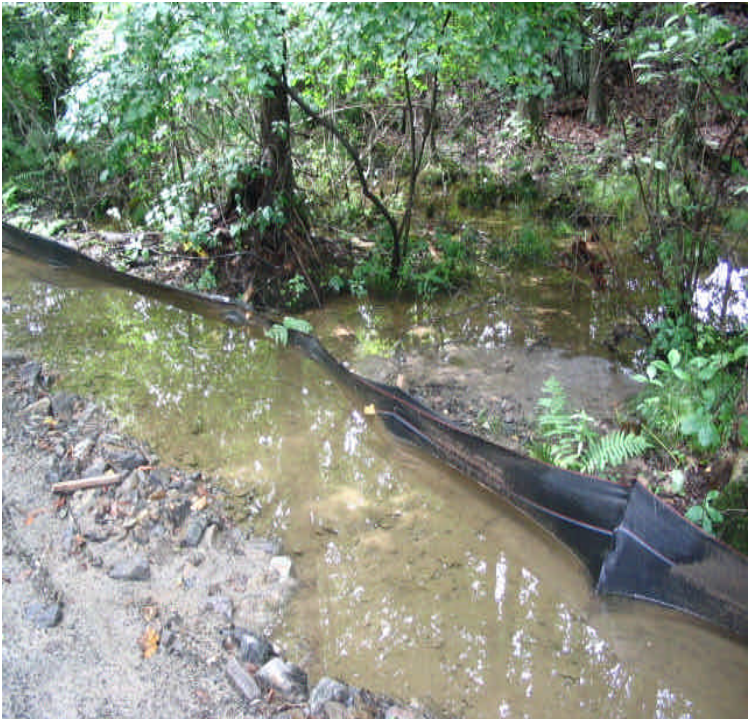
Photo on the left shows the first access road crossing at Archers Lane along the ROW. Sediment has accumulated here in the wetland and needs to be removed. Photo on the right shows a view of the second wetland crossing which will also be restored in the near future. 8/30/06.

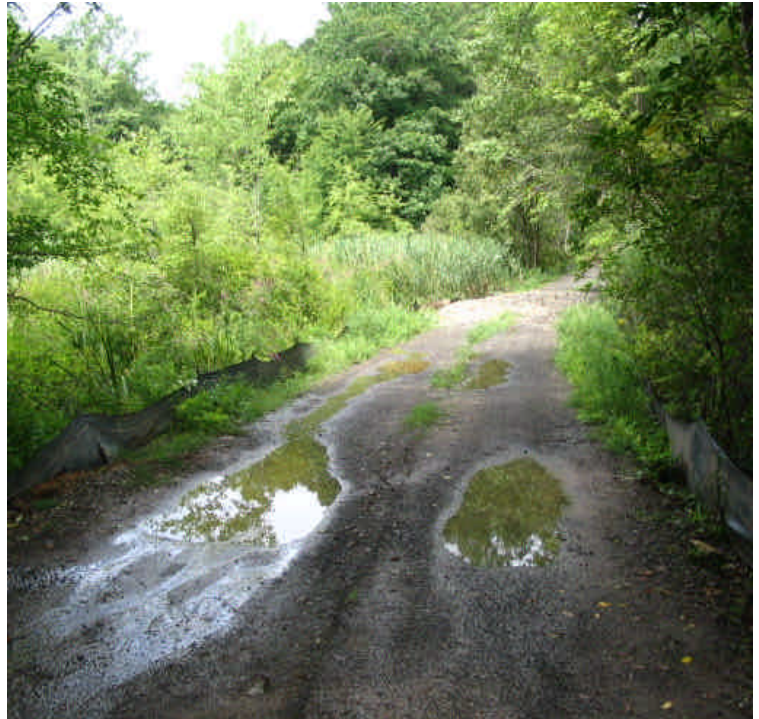
- Even with the recent repairs, erosion on the access road has caused stone to spill over the silt fence further down-gradient. 8/17-8/30/06.	-This is adjacent to the 2 nd wetland crossing and will have to be pulled back and repaired again. 8/17-8/30/06.	- Needs attention (even following recent repairs).
345kV H-Frame	- Work areas are accessed from Hoyts Hill, Chestnut Ridge Rd, Webb Rd, Lime Kiln Rd,	-Continue to monitor the conditions of all access roads. If muddy conditions re-occur, place	- N/A at this time

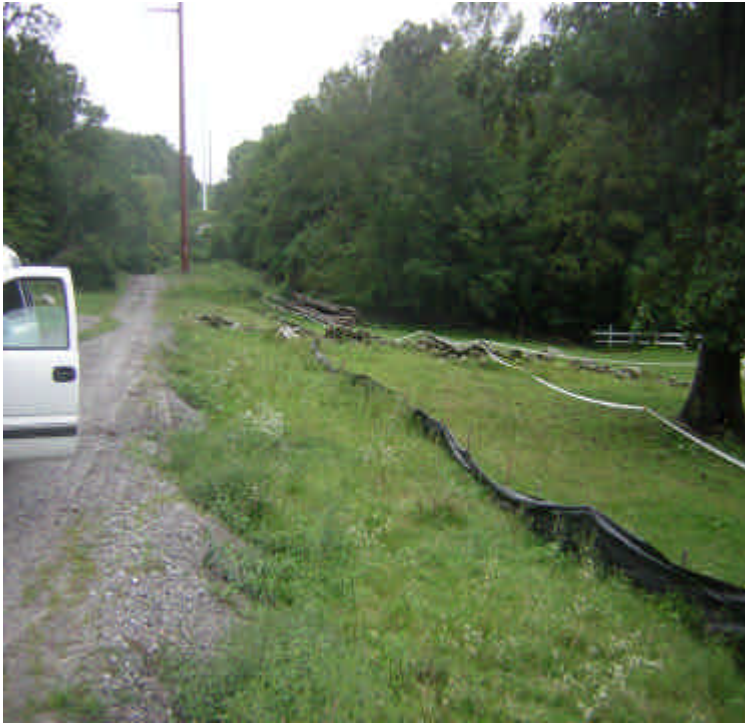
(345kV H-Frame): Photo on the left shows a view of the silt fence at the farm/field area near structure #7 along the Chestnut Ridge Road section of ROW. The area has re-vegetated, but silt fence will remain here until the road within the ROW is restored. Photo on the right shows the wetland crossing near structure #6. 8/30/06.

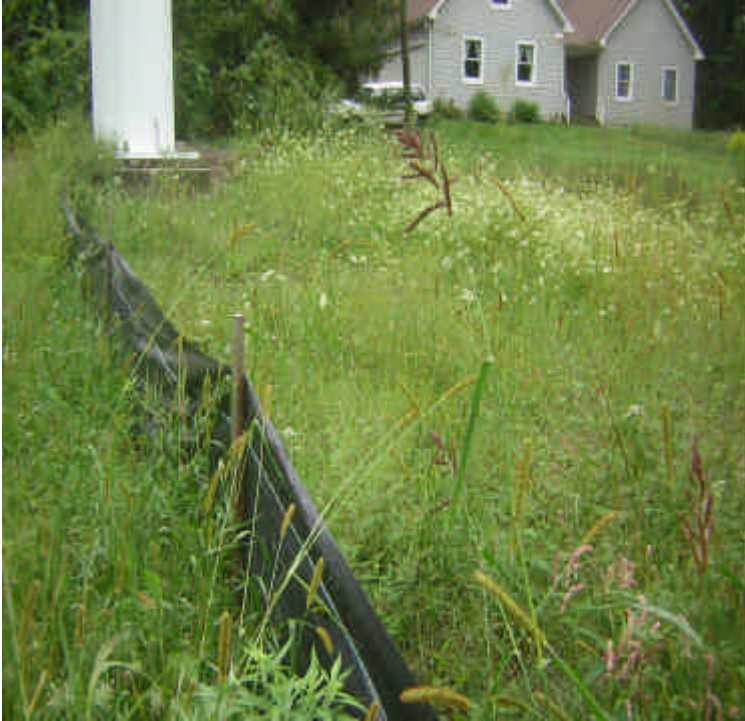
Photo on the left shows the area at structure #9 where the ground is stabilized with vegetation. Silt fence here could be removed. Photo on the right shows a new area of disturbance upgradient of this structure, which should be seeded. 8/30/06.

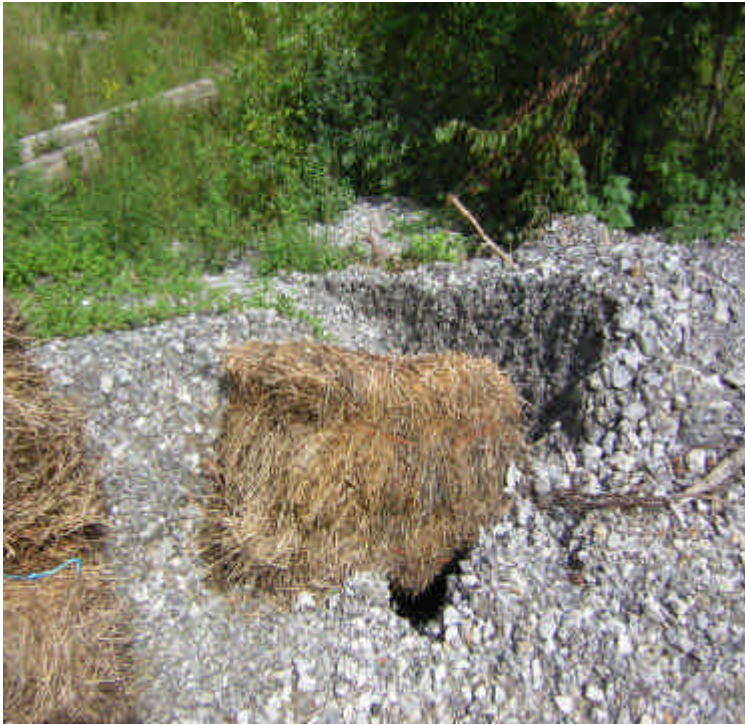
- Erosion continues along the access road near structure #31 but haybales seem to be containing sediment. 7/19-8/30/06. Reese is storing equipment between structure #30 and #31. 8/30/06.	-Continue to monitor and keep stone out of any resource areas. Haybales currently contain the sediment. 7/26-8/30/06.	-Look into more permanent solutions.

The photo on the left shows erosion continuing at structure #31 in the ROW near Costa Lane. (Norwalk Section): Photo on the right shows repairs were made to the silt fence at structure #11051. 8/30/06.

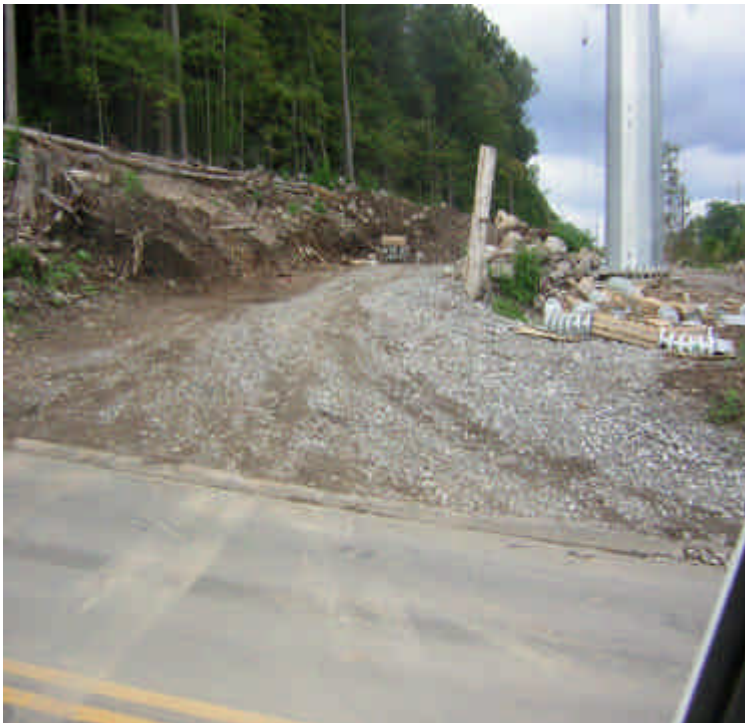
- Minor sediment tracking was noted in Kent Road from the ROW access to the north. 7/19-8/30/06.	- Continue to maintain this entrance and sweep street when necessary. Add more clean stone if needed 7/19-8/30/06.	-N/A at this time
	-Mats remain in good condition over the wetlands in this section. 8/30/06.	- None at this time. 8/30/06.	-N/A
	-Several wetlands are matted to the south of Kent Rd. Haybales are still in place at the wash out areas along the access road. 8/30/06.	- Continue to maintain erosion controls at the areas that continuously wash out. 7/12-8/30/06	- Hay bales were placed at the wash out areas. The remaining silt fence is in good condition.
Line Construction Composite	- No active work was noted in the Archers Lane ROW section this week. 8/30/06.	- None at this time. 8/30/06.	-N/A
345kV H-Frame	- No active work was noted in the Bethel Reservoir, Chestnut Ridge, John Todd Way, or Costa Lane ROW sections this week.	- None at this time 8/30/06.	- N/A

Photo on the left shows minor sediment tracking in Kent Road from the ROW access to the north. Photo on the right shows a view of structure #11048 near Norwalk Junction. 8/30/06.

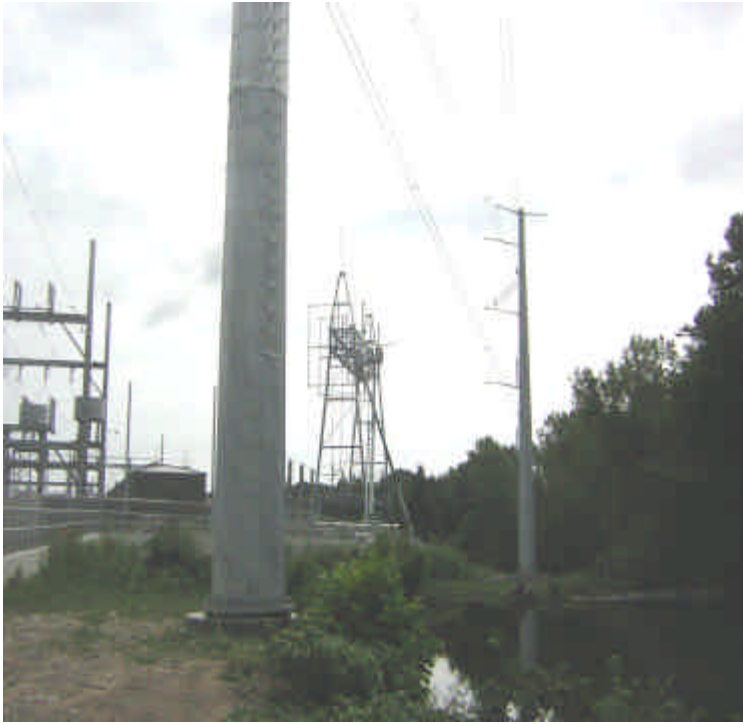
Photo on the left shows a crew dead-ending wire at Norwalk Substation. Photo on the right shows the area at structure #11076 near Perry Ave. This area was re-graded after old towers and foundations were removed, but still needs to be seeded and mulched. 8/30/06.

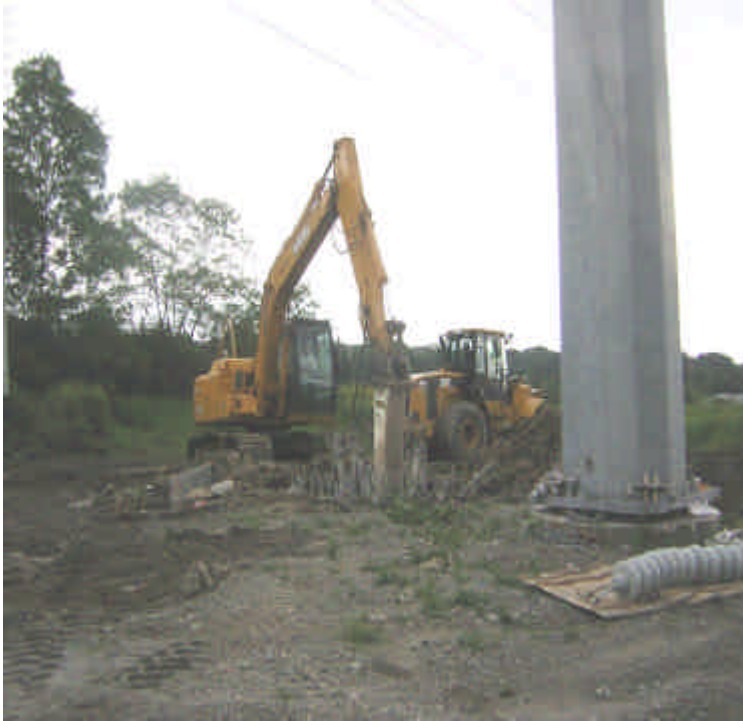
Photo on the left shows a crew removing old foundations in the ROW off Perry Ave. Photo on the right shows crews dead-ending wire in the ROW off North Seir Hill Road. 8/30/06.
